PRESERVATION ASSESSMENT OF MOUNT CALVARY, MOUNT OLIVE, FISHER'S AND POTTER'S CEMETERIES, CITY OF PORTSMOUTH, VIRGINIA

Chicora Research Contribution 533

Prepared By:
Michael Trinkley, Ph.D.
and
Debi Hacker

November 1, 2010

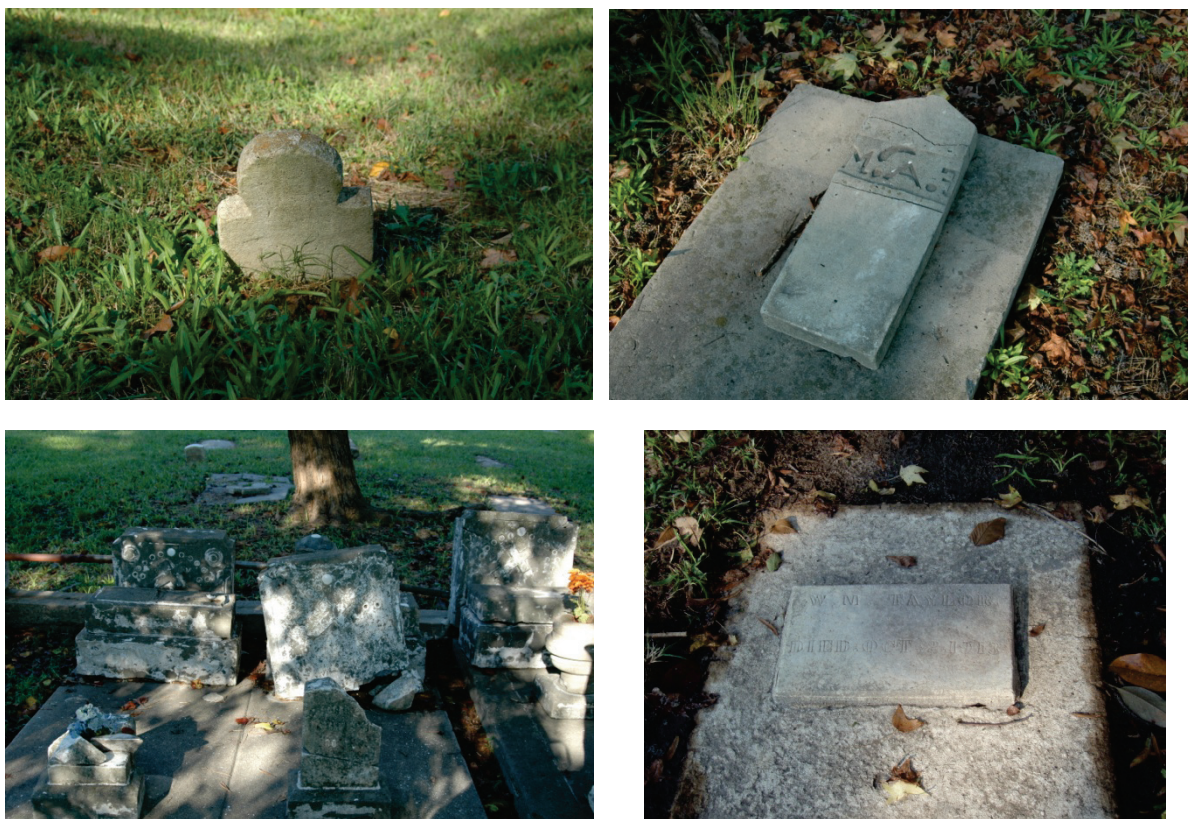
All African American cemeteries exhibit a broad range of cast stone monuments, typically created using a low-aggregate or sandy mix of Portland cement. These monuments were offered by funeral homes, vault companies, and were created by individual families. The fluid nature of Portland cement offered considerable options in the creation of vernacular monuments. Many of the monuments were whitewashed, giving them the final appearance of more expensive marble.

Some of these monuments had industrial letters pressed into the wet mix. Others were hand labeled. In some cases other items were added as decoration, such as colored glass or tiles. The

Figure 43. Examples of cast stone (Portland cement) monuments. These examples show a variety of designs, cast inscriptions, inclusions, and use of whitewash.

Mingo Plot in Mount Olive shows the use of porcelain insulators and door knobs.

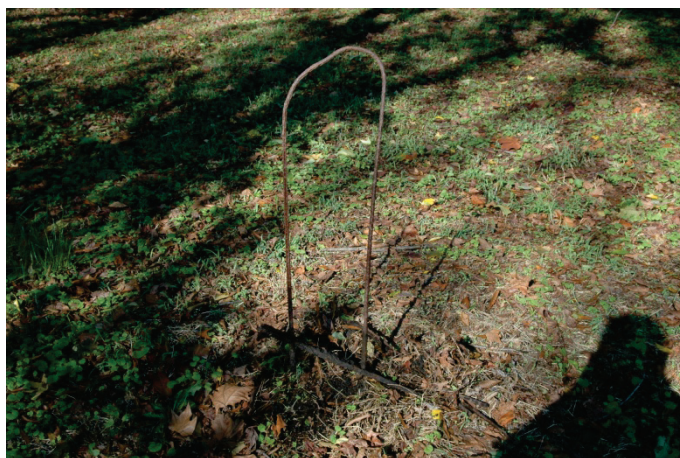
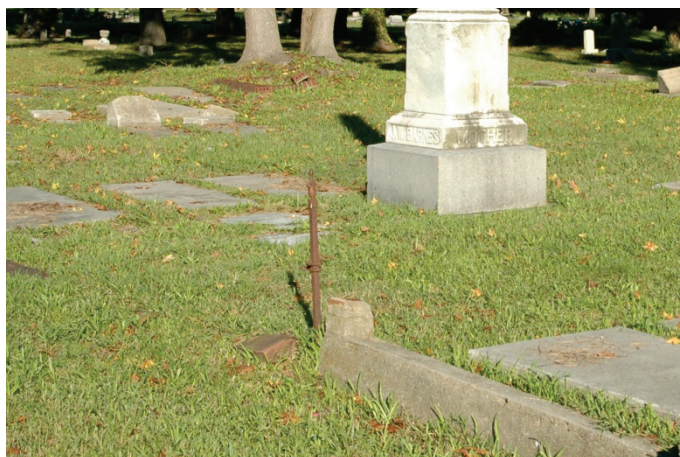
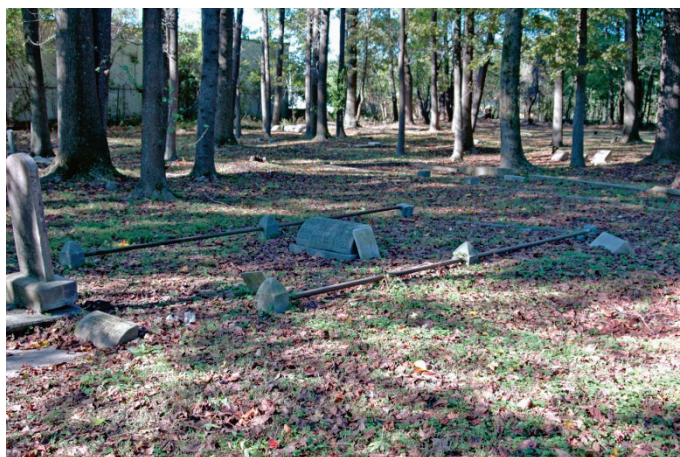
Figure 44. Examples of ironwork in the cemetery complex. Upper photo shows a remnant portion of a "hairpin" section. Middle photo shows a remnant corner post. Lower photo shows a gas pipe fence set in low concrete posts.
